March 8, 2022

RE: Wetlands Report  
Luxor Junior Estates  
SBL: 12-1-41.5  
Town of Fallsburg, Sullivan County

Bruce R. Friedmann  
Senior Environmental Scientist  
Ecological Analysis, LLC

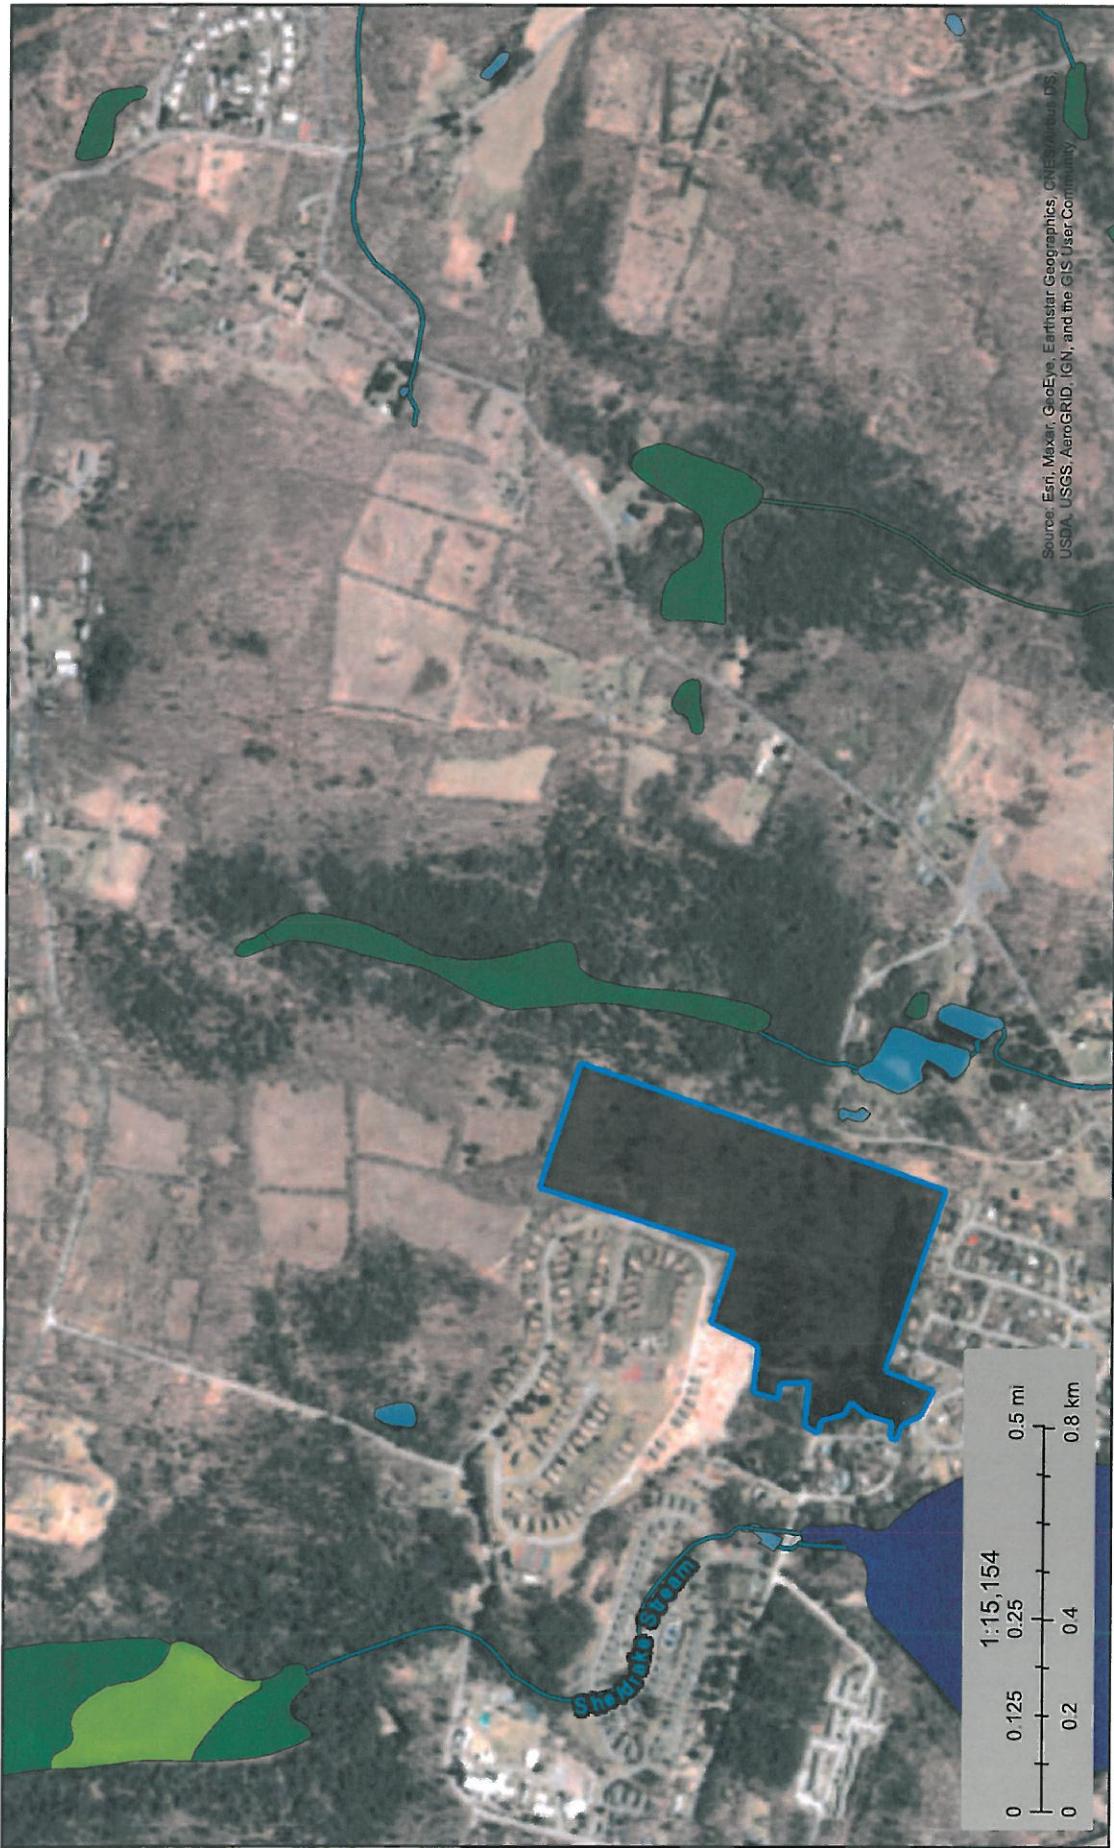
National Wetlands Inventory (NWI)  
This page was produced by the NWI mapper

The online Federal mapping resources of the USFWS National Wetland Inventory (NWI)<sup>1</sup>, shown on the attached aerial mapping of the property and its environs, indicated that there were no mapped wetlands on the property.

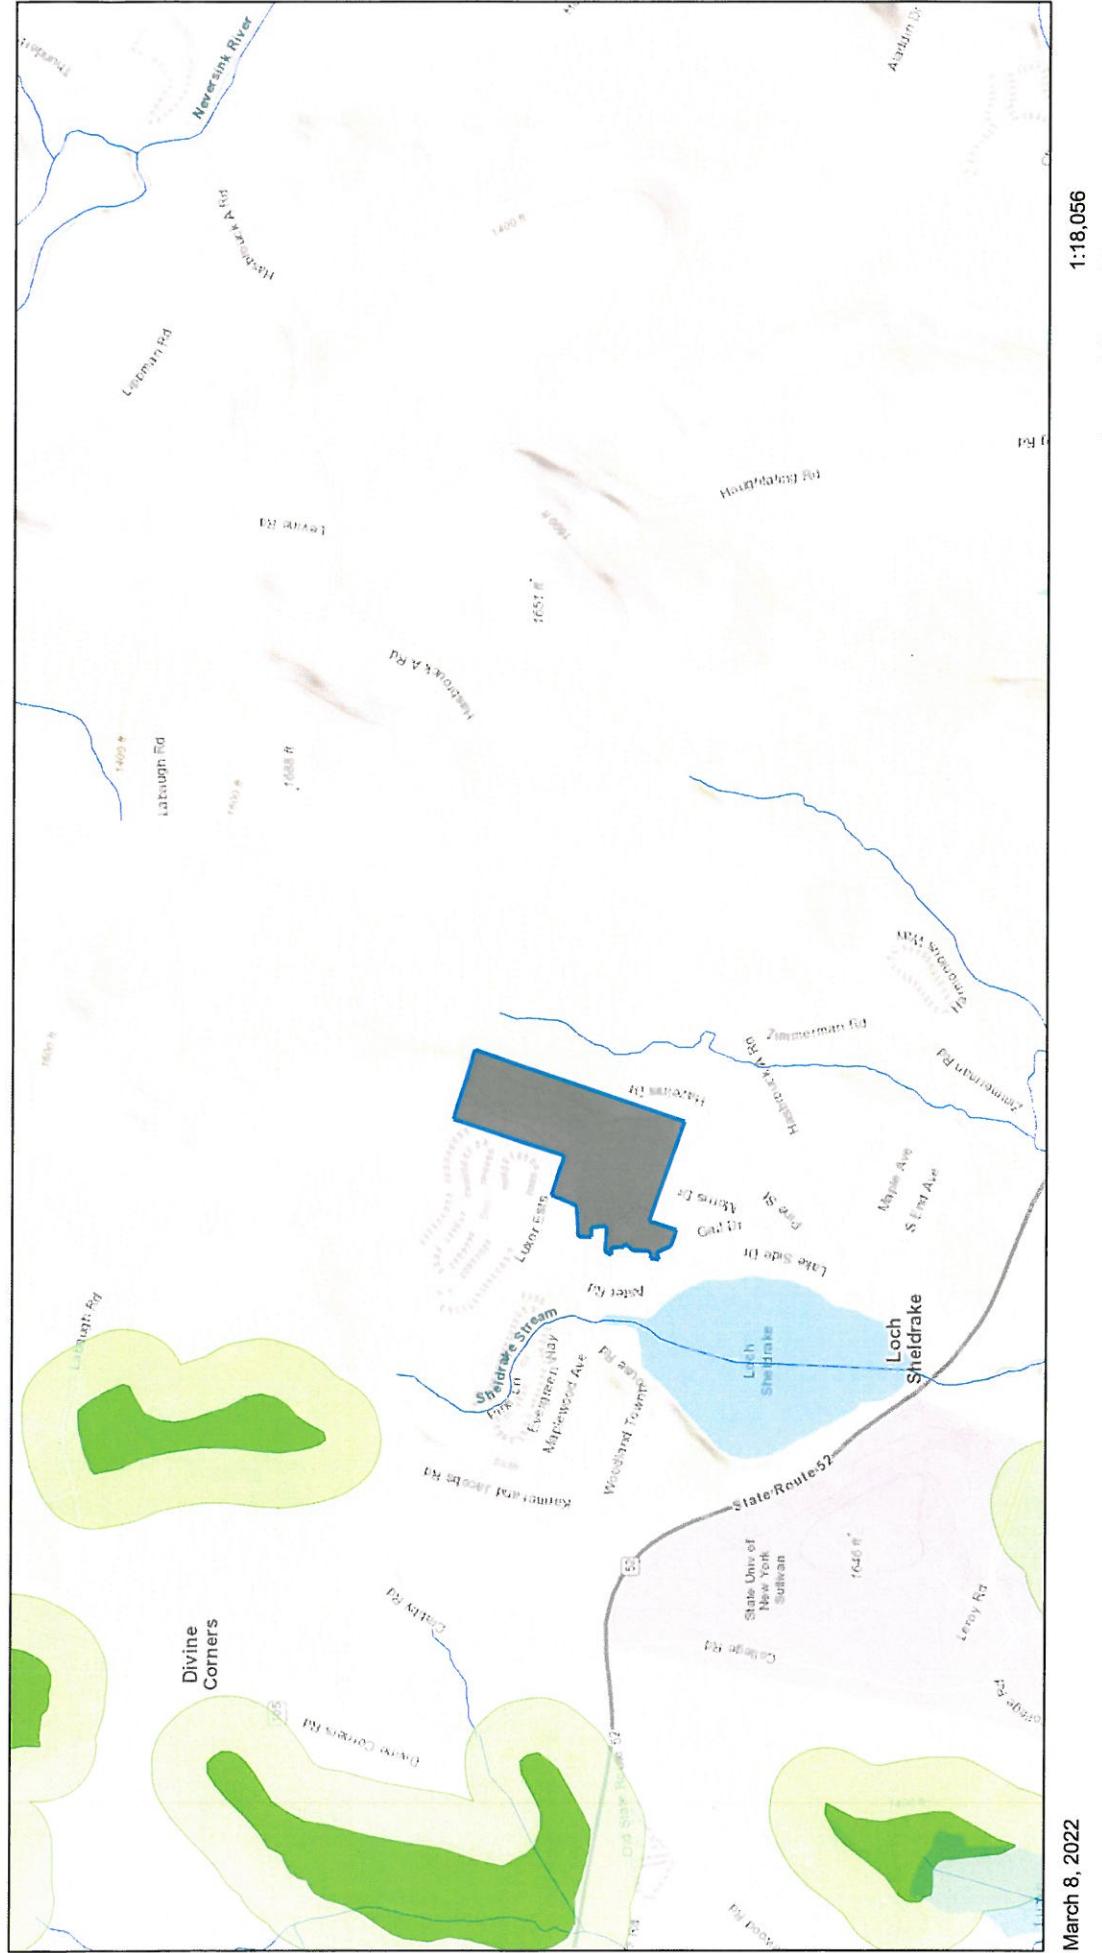
Author: NYSDEC Environmental Resources Mapper  
Not a legal document

The online NYSDEC Wetlands mapper resource does not show any state regulated wetland on this site. The nearest mapped state wetland is LE-28 that is located approximately 0.6 miles to the northwest of the site as shown on the attached NYSDEC Environmental Resource Mapper figure.

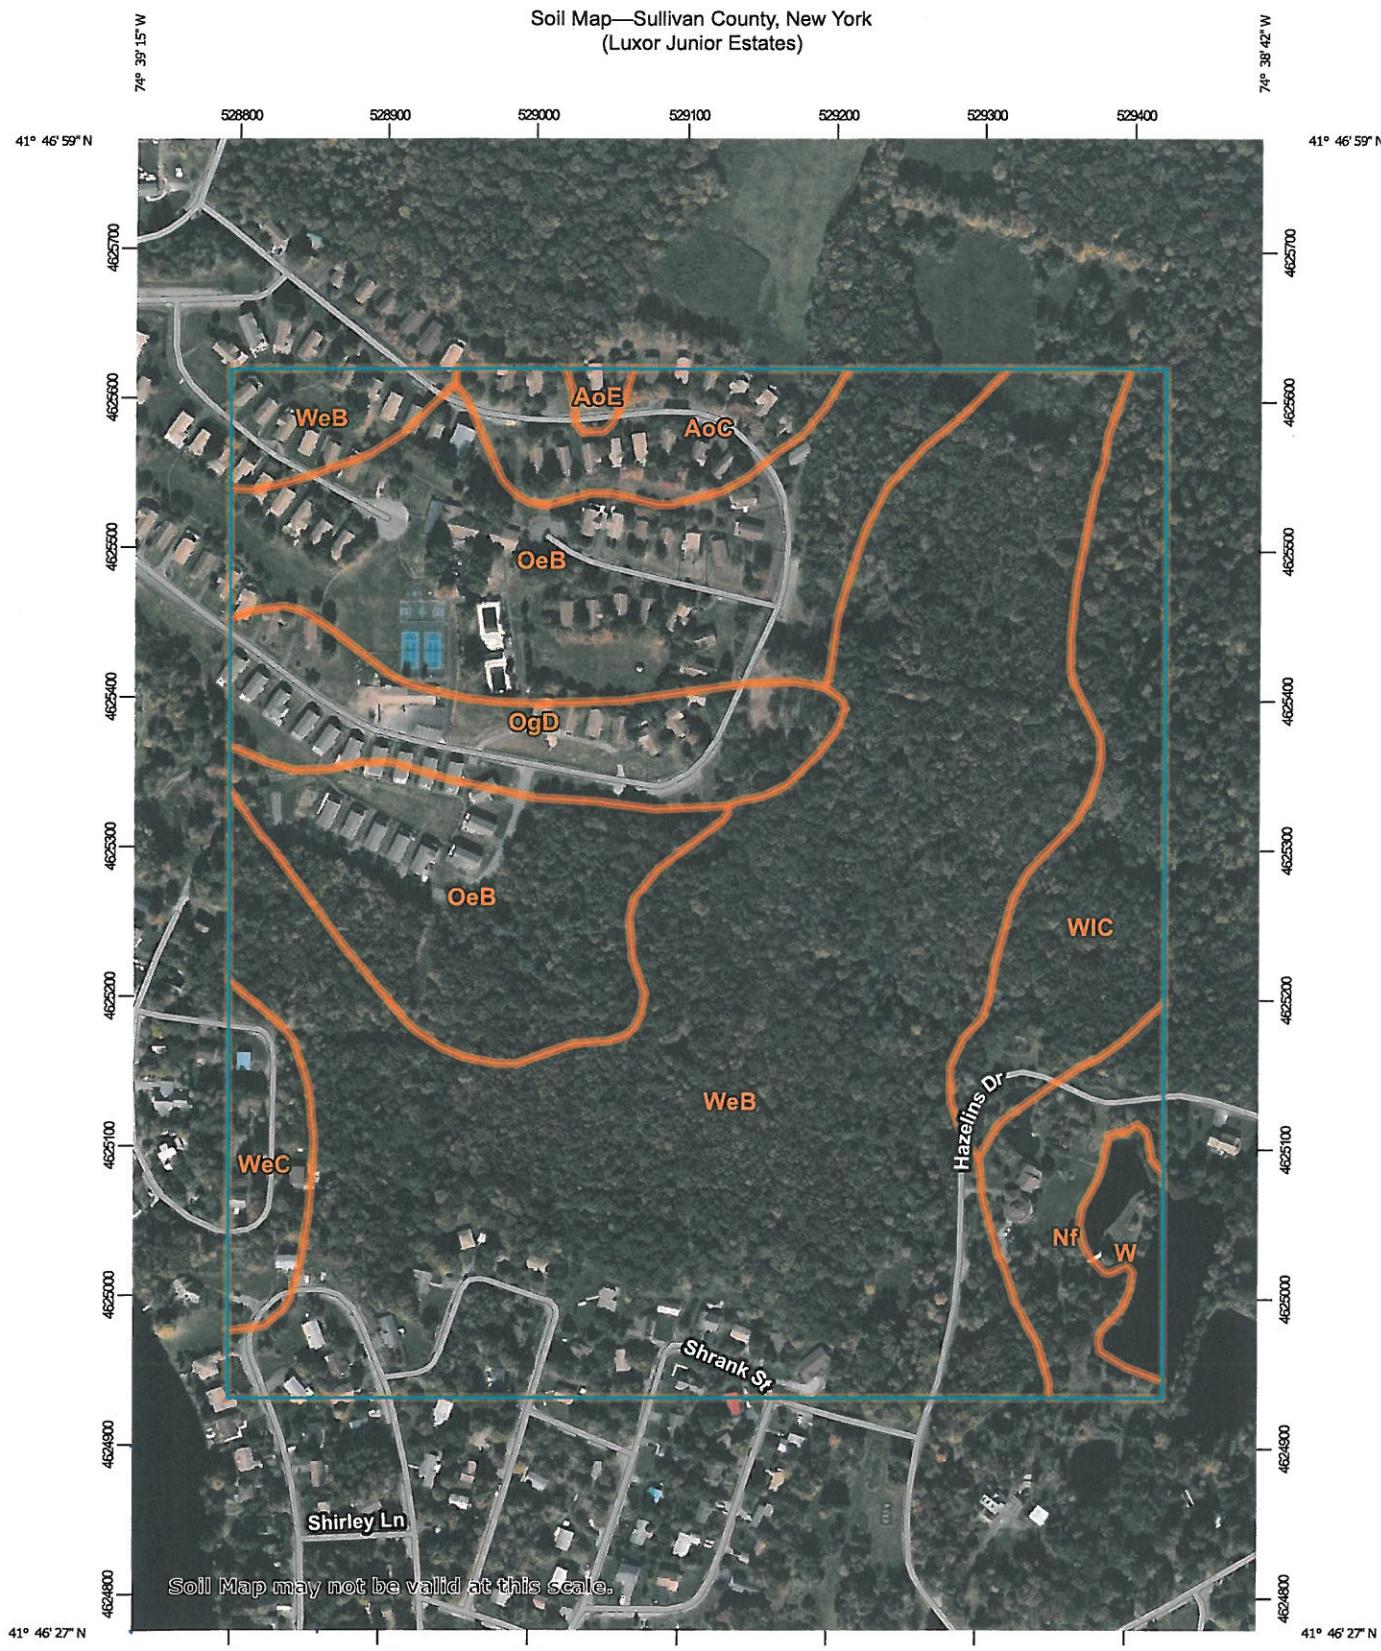
Soil Map—Sullivan County, New York  
(Luxor Junior Estates)

Both the Sullivan County Soil Survey and the United States Department of Agriculture (USDA) online web soil survey from the Natural Resources Conservation Service (NRCS)<sup>4</sup> were reviewed to verify if there were any potential hydric (wetland) soils on property. A copy of the USDA/NRCS soil report for the property is included for your use, showing the landscape scale distribution of soils on and in the vicinity of the site. The two mapped soil units for this parcel were entirely of non-hydric (upland) soils as shown on the attached USDA/NRCS mapped soil survey. These two soils were Wellsboro (We) gravelly or stony loams and Oquaga (Oe) channery silt loams

Map Unit Symbol	Map Unit Name	Acres in AOI	Percent of AOI
AoC	Arnot-Oquaga complex, 0 to 15 percent slopes, very rocky	4.2	3.9%
AoE	Arnot-Oquaga complex, 15 to 35 percent slopes, very rocky	0.3	0.3%
Nf	Neversink and Alden soils, very stony	4.2	3.9%
OeB	Oquaga very channery silt loam, 3 to 8 percent slopes	25.7	23.9%
OgD	Oquaga-Arnot complex, 15 to 25 percent slopes	7.3	6.8%
W	Water	1.6	1.5%
WeB	Wellsboro gravelly loam, 3 to 8 percent slopes	52.8	49.2%
WeC	Wellsboro gravelly loam, 8 to 15 percent slopes	2.6	2.4%
WIC	Wellsboro and Wurtsboro soils, strongly sloping, extremely stony	8.5	8.0%
<b>Totals for Area of Interest</b>		<b>107.2</b>	<b>100.0%</b>

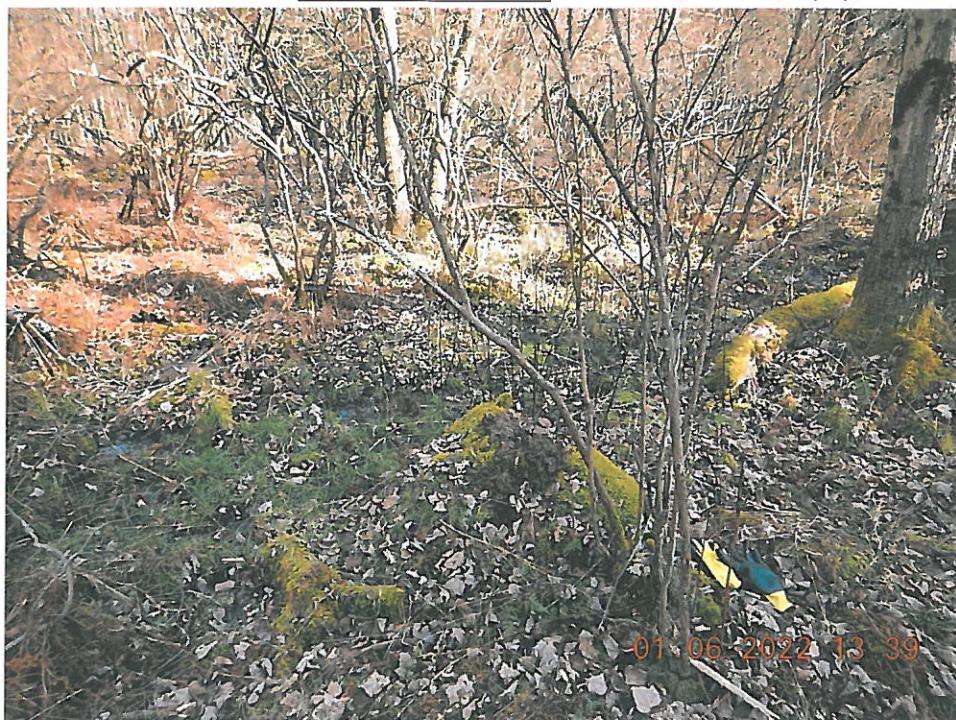
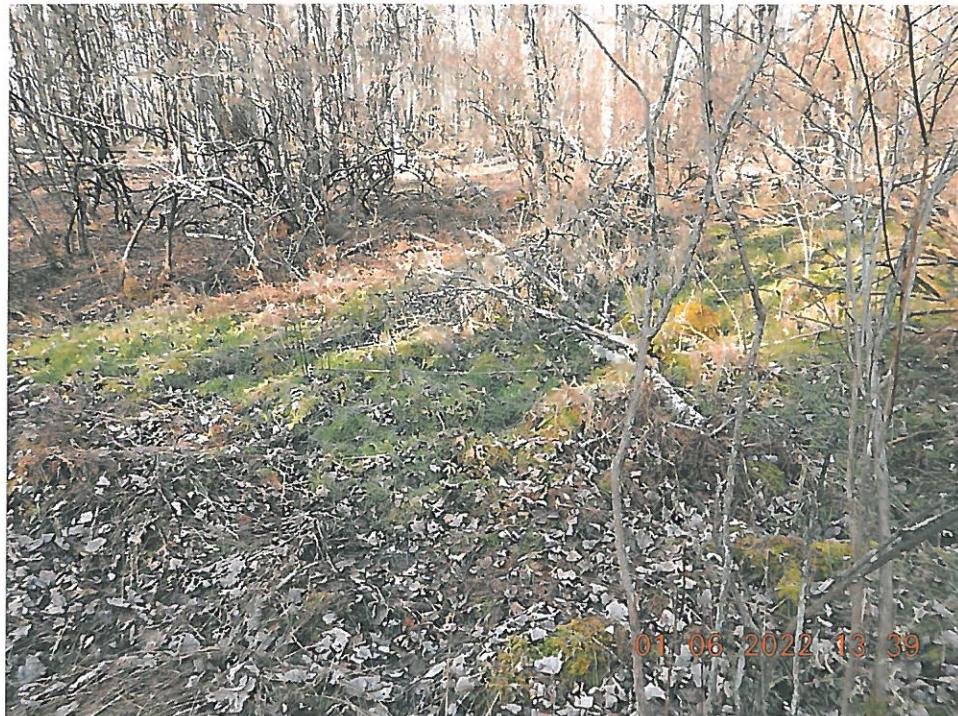
**Wetland C**

The wetland pockets flagged on this property formed in several areas of shallow depressions that were observed to be flooded and saturated at the time of this survey. Soil samples taken within the wetland areas were noted to be marked with indicators of hydric soils as indicated on the attached WetForm for Wetland "C."

The wetland areas on this site derive their hydrology either from several hillside seeps and their associated drainages, or from runoff from adjacent residential properties along the borders of the property. The area flagged as Wetland "C" is located within the interior, forested portion of the site. This depressional area is in a hillslope portion of the site and it receives runoff from the surrounding upland area through groundwater seepage and diffuse overland flows. Wetland "C" was observed to be shallowly flooded throughout most of its areal extent during our visit, while having soils throughout that were noted to be flooded or saturated within the upper 12 inches.

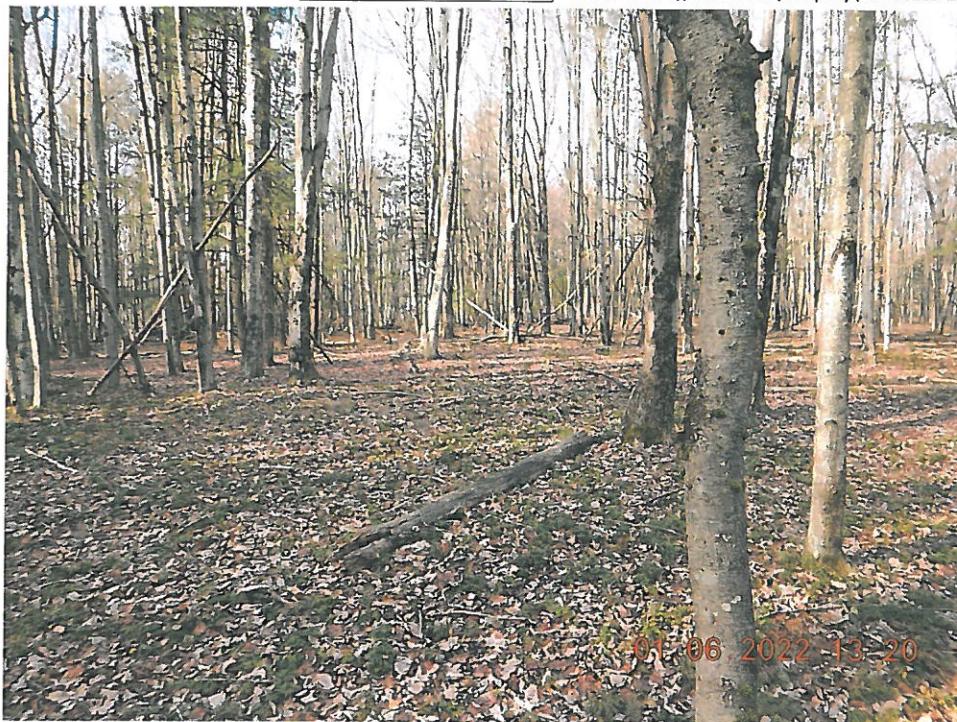
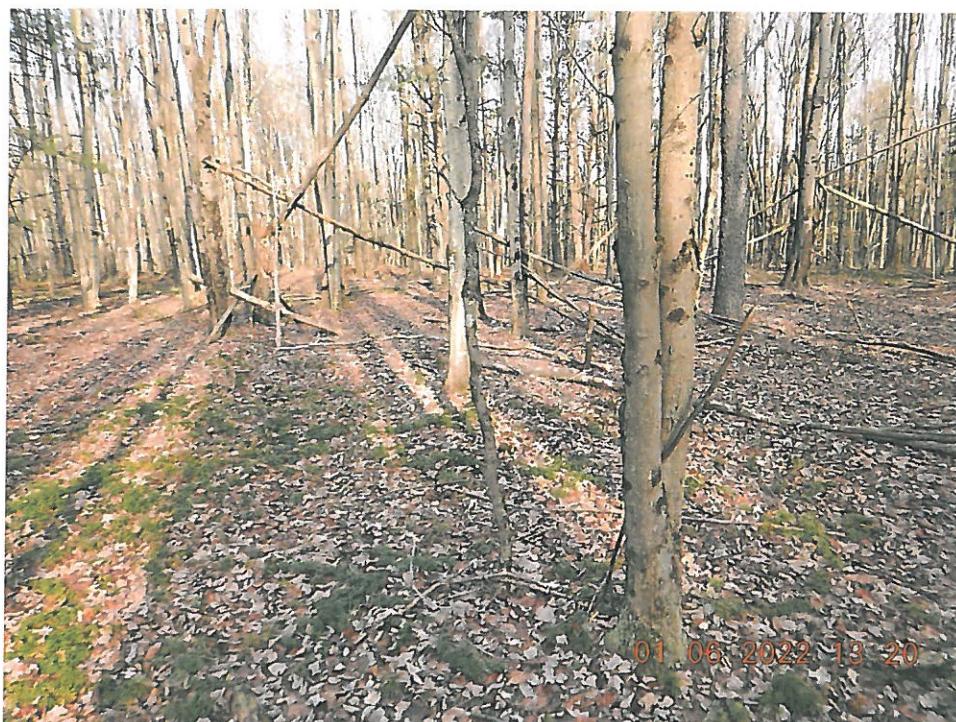
Plot ID: **UPLAND**

The plants dominating upland areas were similarly mostly those of the several mature tree species within the wooded portions of these partially forested parcels. These include: red maple (*Acer rubrum*), eastern white pine (*Pinus strobus*), black cherry (*Prunus serotina*), and sugar maple (*A. saccharum*). Underneath the nearly fully closed canopy formed by these trees, the understory vegetation was sparsely present, occurring only in areas of patchy coverage. The herb stratum which was present in areas, consisted mostly of clubmosses, including princess pine (*Dendrolycopodium obscurum*), groundpine (*D. dendroideum*), and running clubmoss (*Lycopodium clavatum*), This community of species is consistent with upland (dryland) areas.

As mentioned above, upland (dryland) soils dominate on the property. These are areas of soils that have formed in areas of nearly level glacial till plains or on the more steeply sloped terrains on the sides of low hills. These soils are characterized as being very deep, moderately well drained soils. These soils do not maintain proper hydrology to be wetland soils as they dry out during the growing season.
